Lamella Clarifier Retrofit at a Catalyst Plant

Project: Lamella Plate Clarifier Gets Customized Rehabilitation

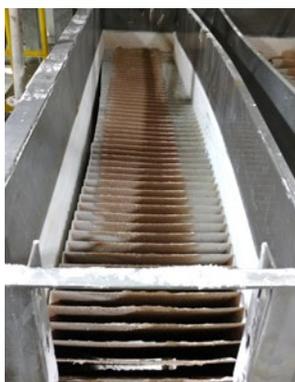
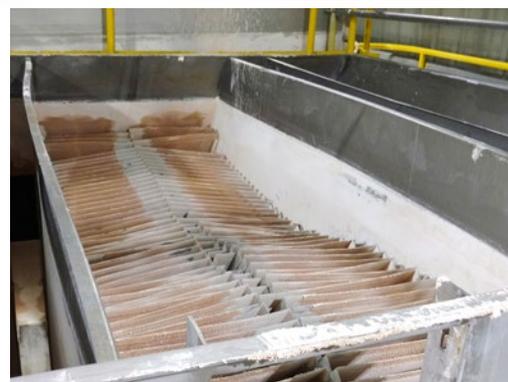
A chemical plant had two under-performing lamella plate clarifiers with internal components that were warped, buckling, and in danger of collapsing. The plate supports, separation walls, and structural members were inadequate for supporting the internals given the stresses from elevated liquid temperatures and process loading requirements.

In addition to the structural deficiencies, the plates were shifting and the system flow was short circuiting, lowering effluent quality. Furthermore, existing access platforms and building structures made access to the units very difficult. A well-engineered, custom solution was required.

Before: Lamella plate clarifier with internal components that were warped, buckling, and in danger of collapsing.

As a result of the evaluation, Monroe proposed to design and fabricate customized rehabilitation kits that would solve the specific structural and process deficiencies, and be able to be installed without deconstructing the separators. This lowered the total project cost and allowed the plant to execute the retrofit during a scheduled shutdown.

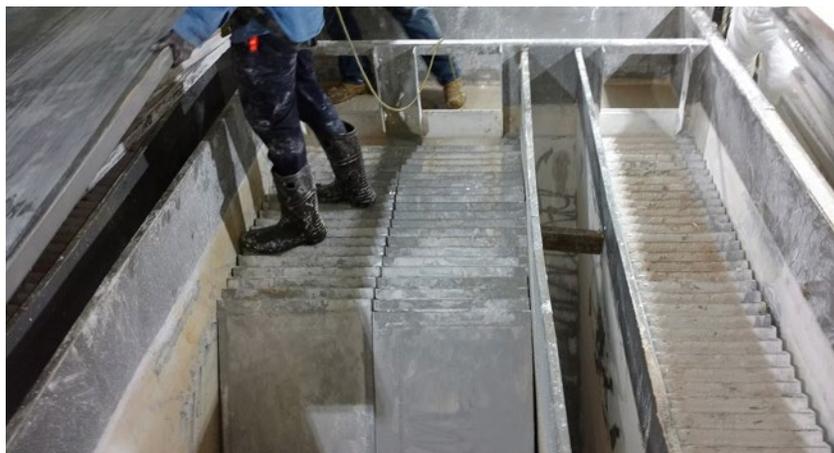
After: Lamella plates installed after new supports for internal structural and process deficiencies were addressed.

Monroe Environmental completed the engineering, fabrication, and delivery of the required components and provided on-site assistance and supervision of the retrofit. The new components re-aligned the internal separation walls, properly supported the plates, and eliminated the short-circuiting.
