Lamella Clarifier Retrofit at a Catalyst Plant

Project: Lamella Plate Clarifier Gets Customized Rehabilitation

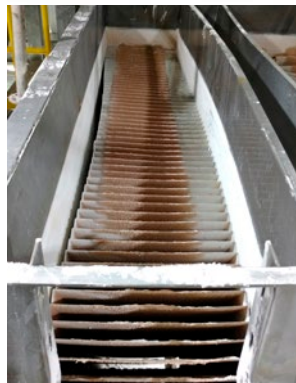
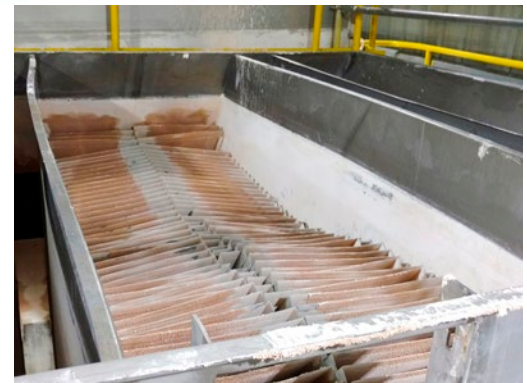
A chemical plant had two under-performing lamella plate clarifiers with internal components that were warped, buckling, and in danger of collapsing. The plate supports, separation walls, and structural members were inadequate for supporting the internals given the stresses from elevated liquid temperatures and process loading requirements.

In addition to the structural deficiencies, the plates were shifting and the system flow was short circuiting, lowering effluent quality. Furthermore, existing access platforms and building structures made access to the units very difficult. A well-engineered, custom solution was required.

Before: Lamella plate clarifier with internal components that were warped, buckling, and in danger of collapsing.

As a result of the evaluation, Monroe proposed to design and fabricate customized rehabilitation kits that would solve the specific structural and process deficiencies, and be able to be installed without deconstructing the separators. This lowered the total project cost and allowed the plant to execute the retrofit during a scheduled shutdown.

Monroe Environmental completed the engineering, fabrication, and delivery of the required components and provided on-site assistance and supervision of the retrofit. The new components re-aligned the internal separation walls, properly supported the plates, and eliminated the short-circuiting.

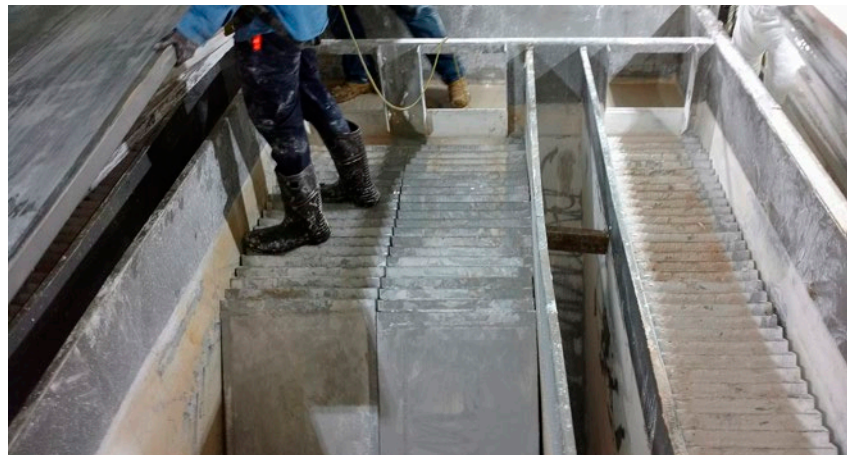
After: Lamella plates installed after new supports for internal structural and process deficiencies were addressed.
