Packed Tower Scrubber Rebuild

Extending the Life of an Existing Fume Scrubber

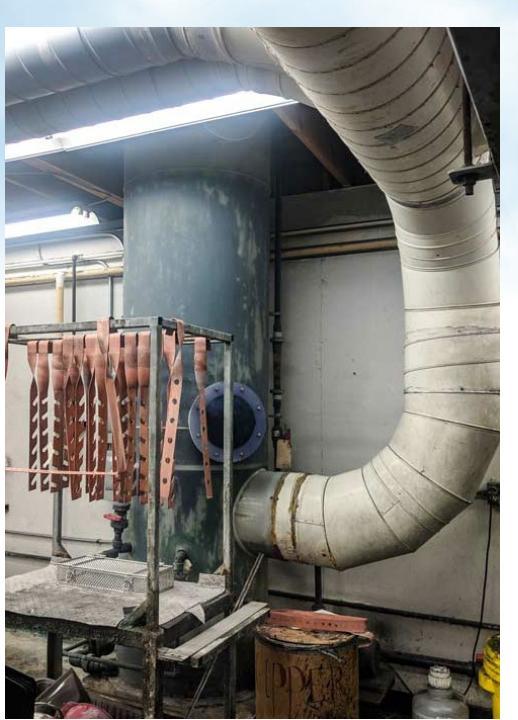
Before: (Left) A build-up of bacteria and particulate, as well as overheating and pipe corrosion rendered the customer's scrubbing system ineffective.

- A new additional access door was added to allow for future cleaning/improved maintenance.
- A new recirculation pump, flow meter, and chemical feed pump replaced existing parts that were corroded and overheating.

- **Drain lines from the fan were installed,** allowing a path for acid to drain back into the scrubber. Without this, excess acid could potentiality damage the roof.
- Scrubber outfitted with all new PVC piping. The existing metal pipes were corroding from acid service.
- A Capsuhelic differential pressure gauge was installed to allow the customer to easily monitor the performance of the scrubber and to determine new maintenance intervals.
- Improved packing media, mist pads, and new spray nozzles were installed to resist build up of bacteria and particulate.
- The unit was totally cleaned inside and out.
- Cracks on existing tower were repaired by Monroe plastic welders.
- Training was provided to operators and maintenance staff.

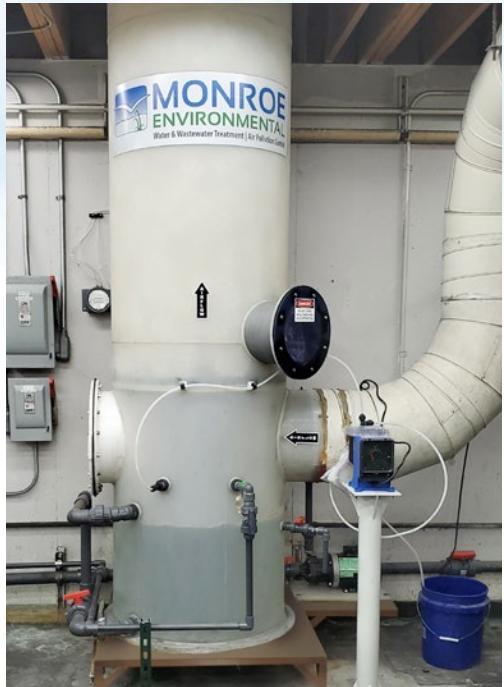
After: (Right) A system rebuild by Monroe's Service team transformed this competitor's failing system to an efficient Monroe Scrubber.

Drain lines from the fan were installed, allowing a

path for acid to drain back into the scrubber.
