## Extending the Life of an Existing Fume Scrubber

## Case Study: Packed Tower Scrubber Rebuild

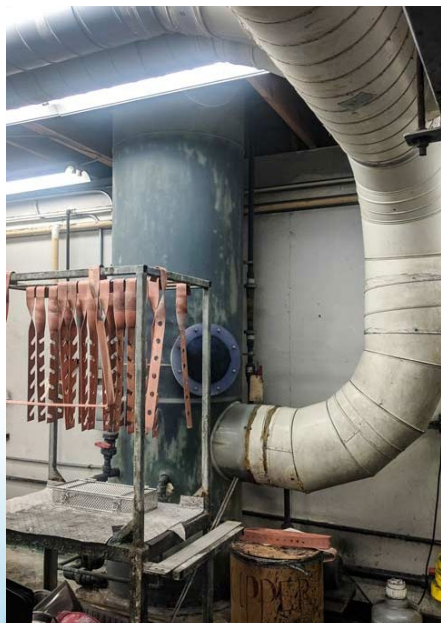
**Before:** (Left) A build-up of bacteria and particulate, as well as overheating and pipe corrosion rendered the customer's scrubbing system ineffective.

- **A new additional access door was added** to allow for future cleaning/improved maintenance.
- **A new recirculation pump, flow meter, and chemical feed pump** replaced existing parts that were corroded and overheating.

- **Scrubber outfitted with all new PVC piping.** The existing metal pipes were corroding from acid service.
- **A Capsuhelic differential pressure gauge was installed** to allow the customer to easily monitor the performance of the scrubber and to determine new maintenance intervals.

- **Improved packing media, mist pads, and new spray nozzles** were installed to resist build up of bacteria and particulate.
- **The unit was totally cleaned** inside and out.

- **Cracks on existing tower were repaired** by Monroe plastic welders.
- **Training was provided** to operators and maintenance staff.

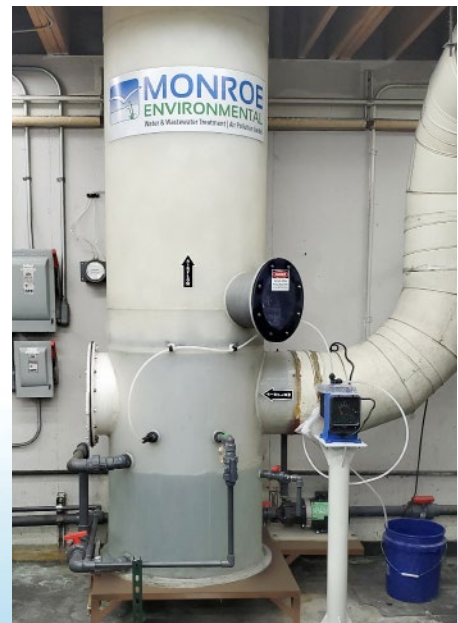
**After:** (Right) A system rebuild by Monroe's Service team transformed this competitor's failing system to an efficient Monroe Scrubber.

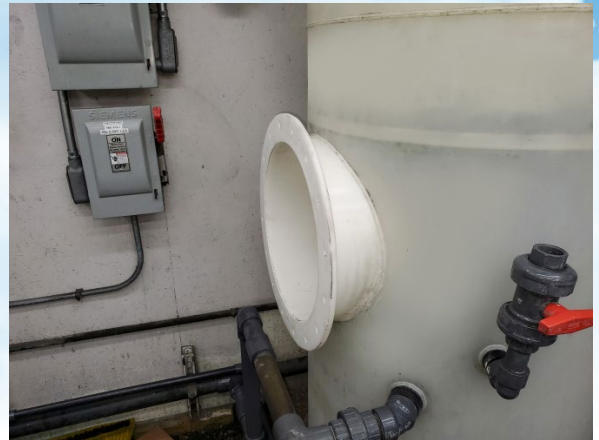
*A new additional access door was added to allow for future cleaning/improved maintenance.*

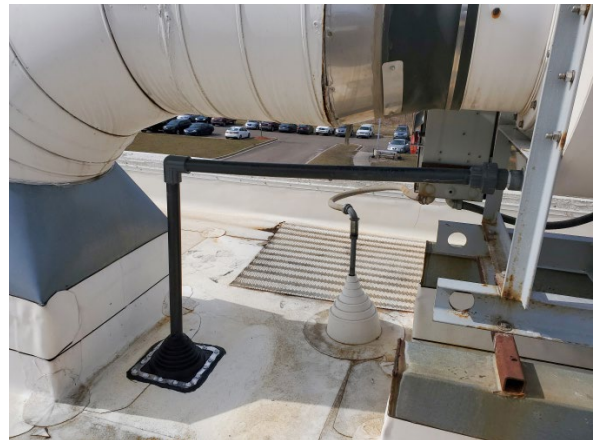
*Drain lines from the fan were installed, allowing a path for acid to drain back into the scrubber.*

- **Drain lines from the fan were installed**, allowing a path for acid to drain back into the scrubber. Without this, excess acid could potentially damage the roof.

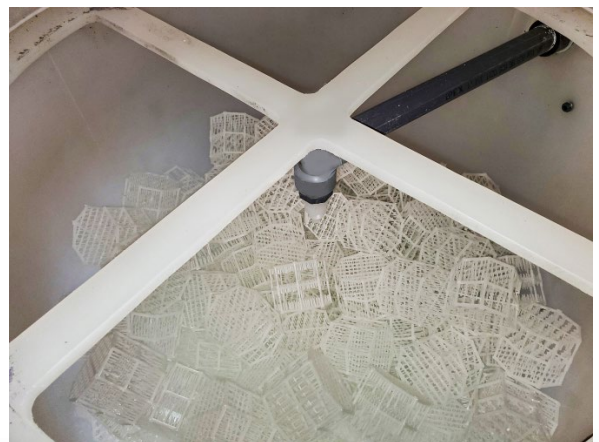
*Improved packing media, mist pads, and new spray nozzles were installed to resist build-up of bacteria and particulate.*
