Replacement of Two 130 ft. Secondary Clarifiers at a 25 MGD Wastewater Treatment Facility

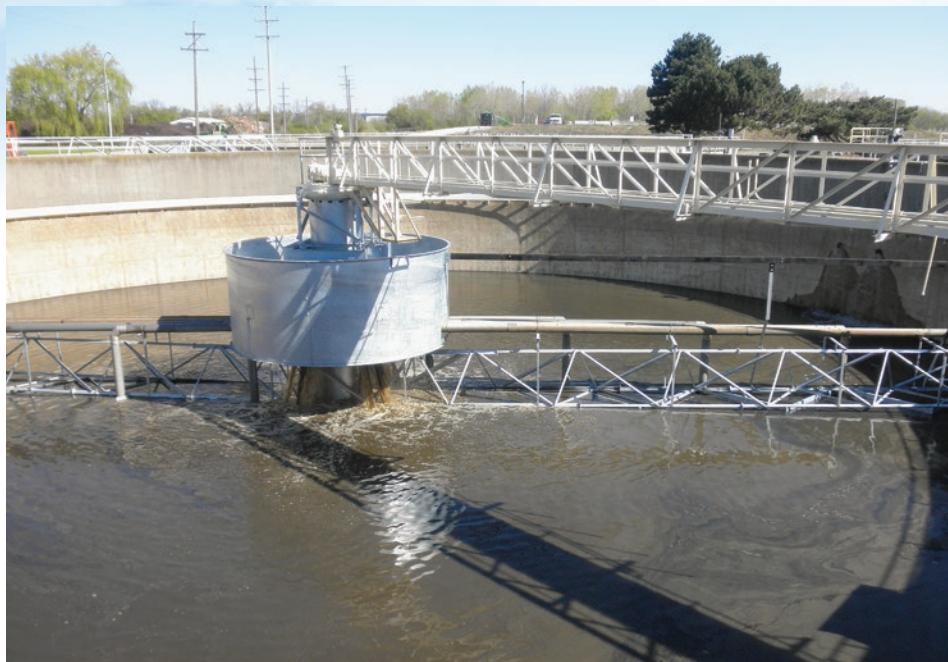
The rebuilt Secondary Clarifier back in service.

Both 130 ft. clarifiers returned to full operation and are currently in use at the facility. A previous clarifier rebuild installation at the same plant with a non-Monroe clarifier took roughly one month to complete versus the three days required to install each Monroe clarifier. These rapid installations — a direct result of our shop assembly and testing — maximized clarifier uptime and allowed the plant to return to normal operating procedures faster than the competition.

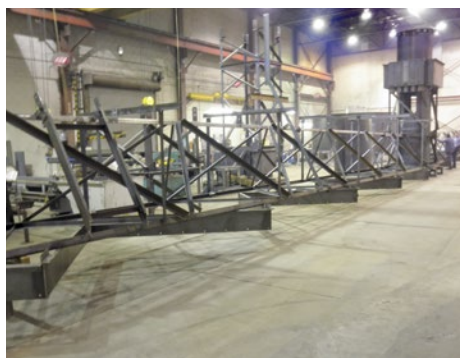
Fabrication in shop

Monroe Environmental® sent a team to the site to inspect the old equipment and take the necessary measurements. Monroe oversaw the removal of the clarifier internals and designed a new system to perfectly fit the existing concrete tank. Monroe's team of shop technicians and AWS certified welders fabricated the new steel equipment and fully assembled the unit in their shop.

Each 130 ft. clarifier rake arm was fully assembled and pre-fit to simulate the angle of the existing clarifier tank floor. This ensured that on-site installation would be as fast as possible, with no field engineering or fabrication required.

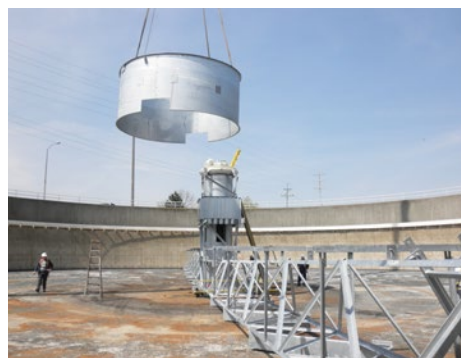
Installation of rebuild components

After testing and alignment was completed, the new internals were shipped to site for replacement. The Monroe team oversaw the installation of the new equipment to ensure correct assembly, and the entire on-site installation process for each clarifier took only three days!
