WET SCRUBBER REBUILDS & RETROFITS

Why Rebuild or Retrofit Existing Wet Scrubbers?

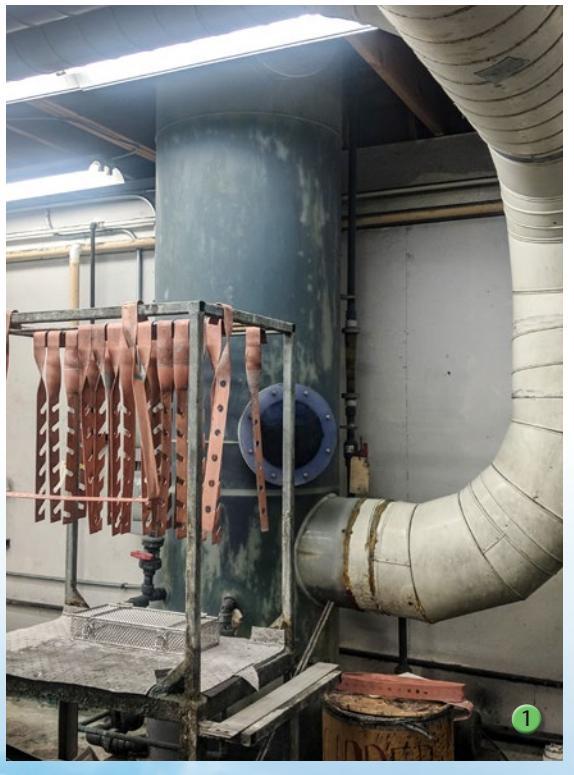
Before (Photo 1): A build-up of bacteria and particulate, as well as overheating and pipe corrosion rendered the customer's scrubbing system ineffective.

A medical implant manufacturer had noticed a steady decline in the effectiveness of their fume scrubbing system. Low flow and low efficiency led to inadequate control of nitric acid fumes. Monroe was called to assess the system and make recommendations. It was determined that a rebuild of the existing scrubber (non-Monroe) was the fastest, most cost-effective solution.

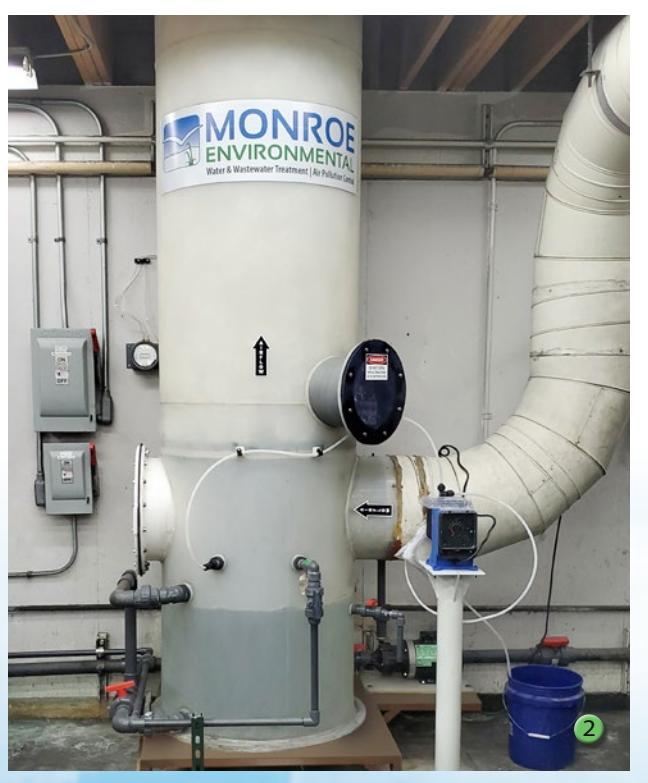
After (Photo 2): A system rebuild by Monroe's Service team transformed this competitor's failing system to an efficient Monroe Scrubber.

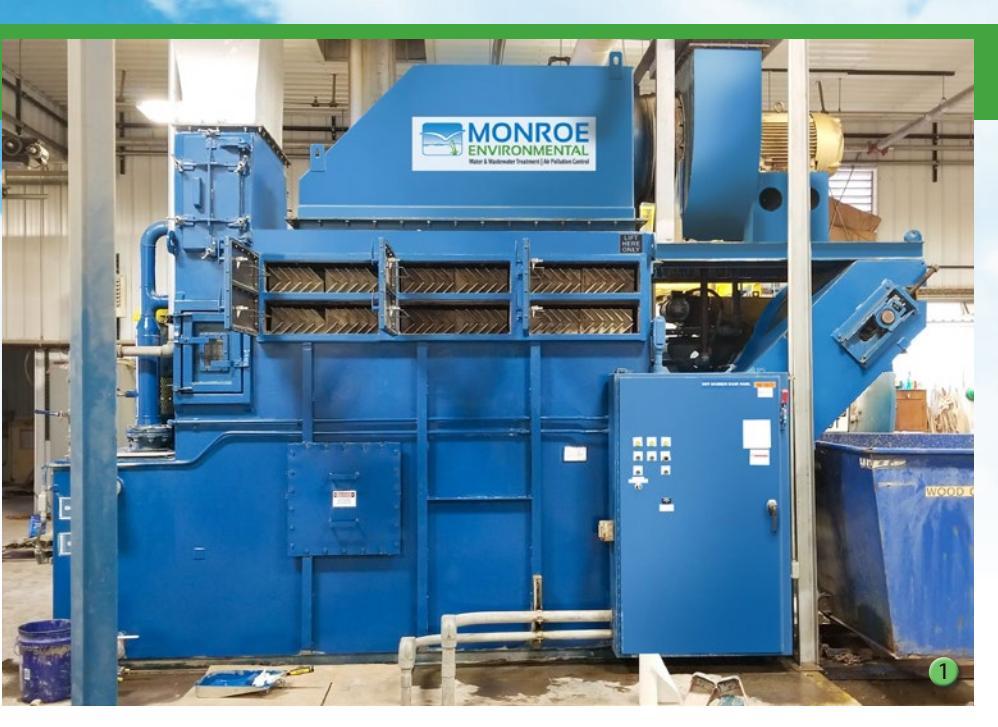
After (Photo 1): Monroe reinforced the scrubber body where it was leaking from the drag conveyor wearing through, replaced the mist eliminator supports, replaced the venturi access doors, replaced the venturi throats, replaced all door gaskets and fasteners, and painted the unit.

A wood finishing mill that specializes in hardwood flooring and other high end carpentry had put its Dual Throat Venturi Scrubber through years of hard use.

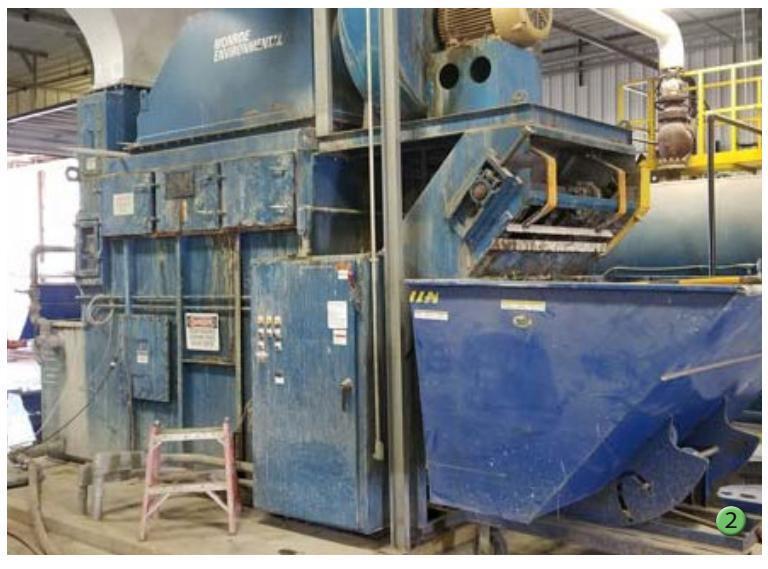
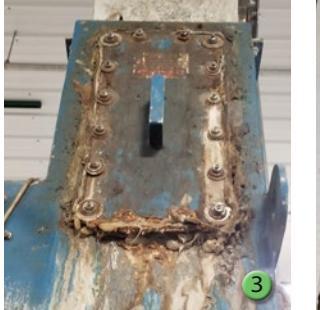
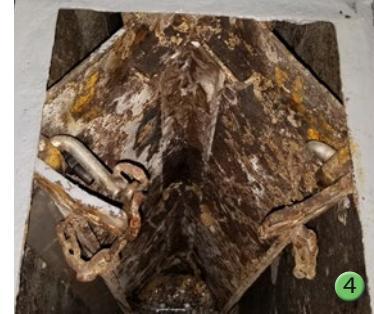
Before (Photos 2, 3, 4): After years of 24/7 service, a high inlet gas temperature of 350°F, high inlet loading of abrasive particulate, and lack of a sewer drain connection, the unit had serious issues to address.

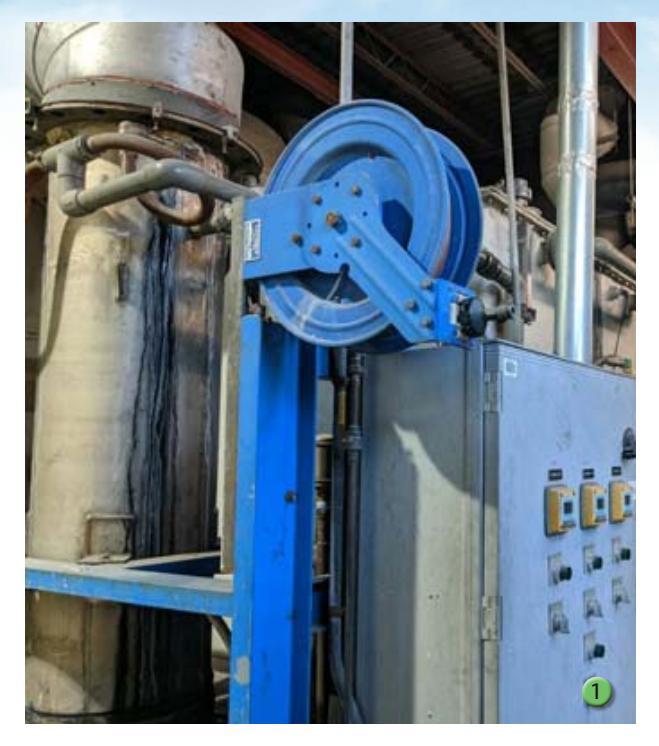
A site visit to evaluate an existing wet scrubbing system observed wear and tear after being in operation for almost 20 years. A replacement Quench Tower was required to be retrofit to the existing wet scrubbing system due to leaks causing excessive corrosion. Scrubber housing and internals were also in disrepair, with some components able to be updated to current technology for improved performance.

Before (Photo 1): The existing Quench Tower was leaking in several areas, and the downstream scrubber was in disrepair. The FRP housing had many cracks and leaks, and scrubber internals were outdated design with low performance.

To withstand the temperatures, the new quench design included a rubber boot, new spray nozzles, and hard piping instead of the existing flex piping. Additional supports were also added to the inlet duct to reduce load on the quench tower.

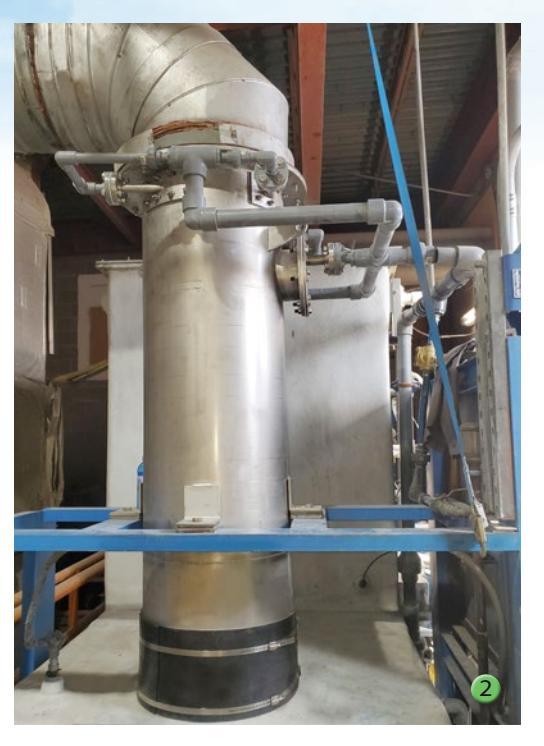
After (Photo 2): Replacement inlet quench with updated design, connecting piping and rubber boot. The scrubber FRP housing was also repaired to eliminate leaks, and scrubber internals were replaced for improved efficiency.
